Water conservation in Curaçao; using traditional earthen dams

Gerard van Buurt

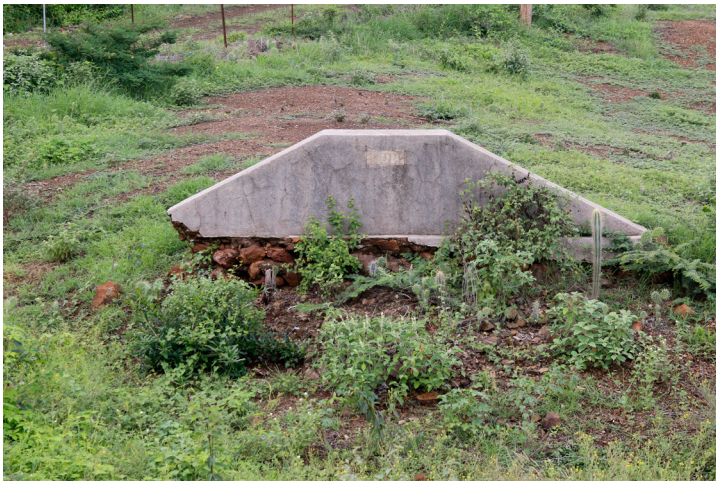
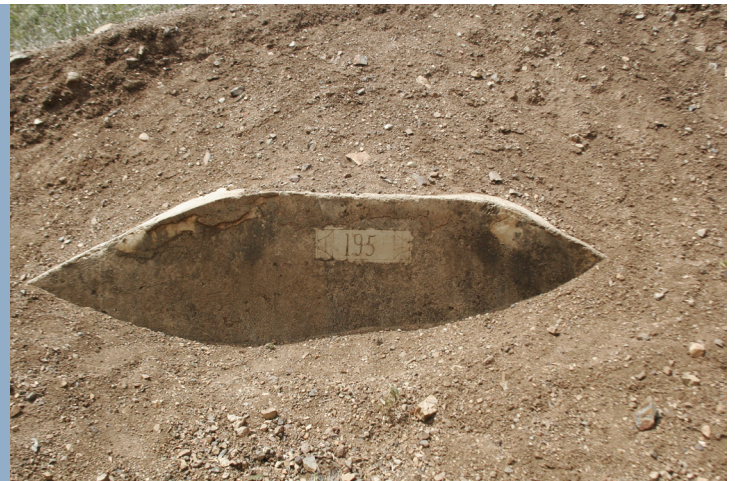
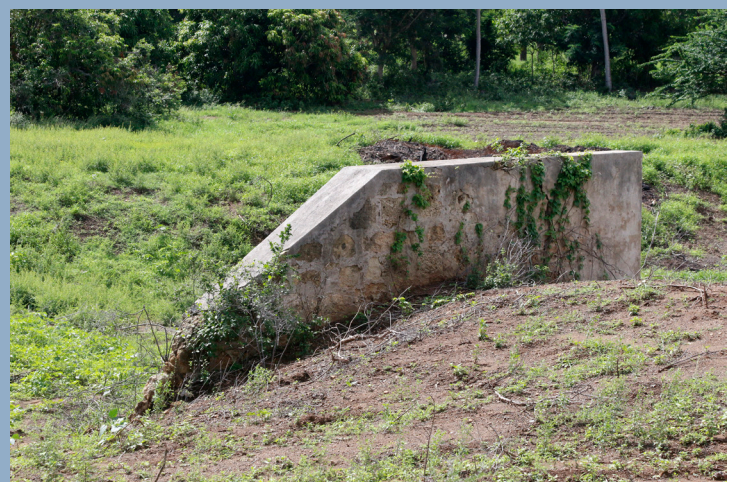
Masonry protection of dam ends. Usually the dam ends are protected. Larger dams also have overflow structures.

In these pictures the dam body has slumped and has been eroded through the years. The dam end protection of dam 132 (top left, taken in 2016). This dam was constructed after 1908 (it was built as part of the dam-building activity plan by Ir. M.C. Fael, 1908). The dam head has been undercut by overflowing water. This enables us to see the foundation of the masonry wall. In its present state the dam is not functional anymore.

When dams are repaired, trees growing on the dyke are removed, new earth, usually dug out of the basin, is added on top and is compacted with a small bulldozer. See picture of dam 195 (top right, taken at Pannekoek in 2007). In this case the earth has not been properly compacted. Earth has simply been piled on top. Very likely a loader was used instead of a bulldozer. In Dutch we say "prutswerk". This is what happens when accountants decide that the D4 is too old and loaders should be used.

The bottom right photo was taken Dam Kacho at Rio Magdalena.

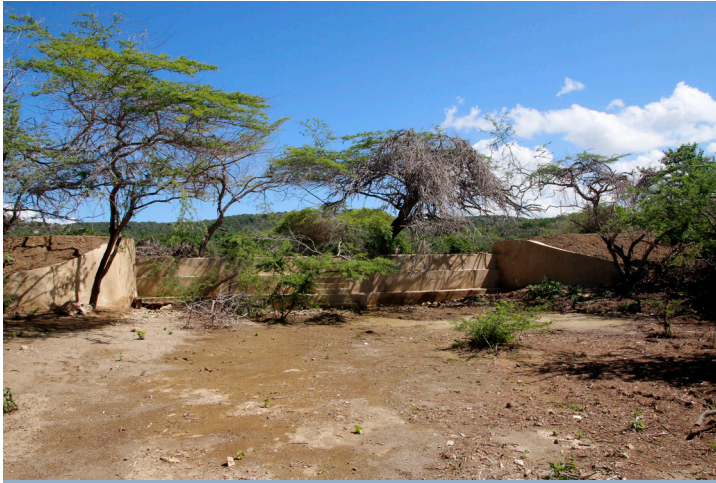
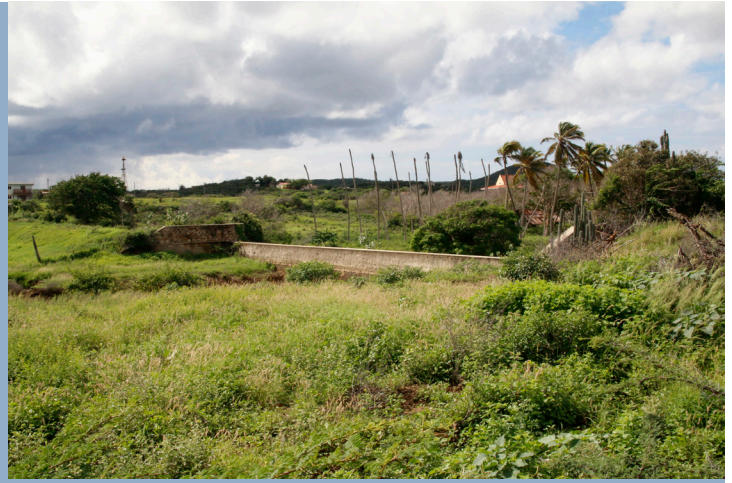
Overflow structure/Spillway, locally called sakadó, of the dam at Jan Kok (6 Dec, 2016). There used to be a well downstream, which has been filled in and paved over by a road. The well was situated not far from where the picture is taken; it is marked on the old "Werbata" map of 1911-1915.

In the lower picture the much larger overflow structure/spillway of Dam Kacho at Klein Sta. Martha. The coconut trees in the background died during a previous period of drought.

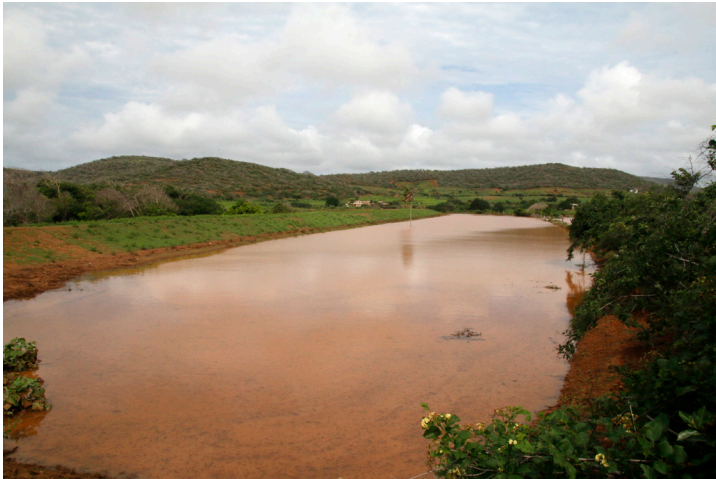
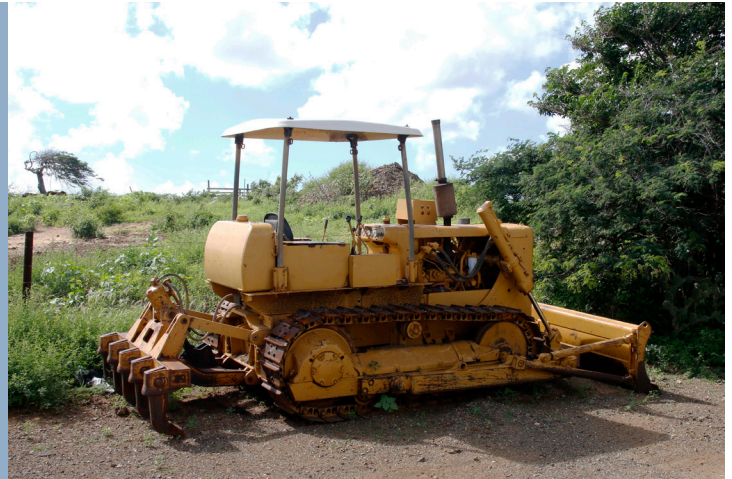
The Dam Kacho at Klein Sta. Martha. This dam had been properly repaired about six months before this picture was taken; on November 27, 2016, using the D4 caterpillar bulldozer pictured on the right. This bulldozer is privately owned.

Caterpillar D4 is a light bulldozer, used for building dams. Although D5, D6 bulldozers and various loaders are also used, the D4 is considered the most suitable for this kind of work.

D 4, see former page). Additional clay is brought in till the fill is about a meter or more above field level (depending on the height of the dam). It is again compacted with the caterpillar. Then the original fill, which was taken out while digging the trench, is applied to the sides of the dam, and everything is topped off with diabase soil till the desired height is attained. The ends of the dam are protected with stone walls and a stone masonry

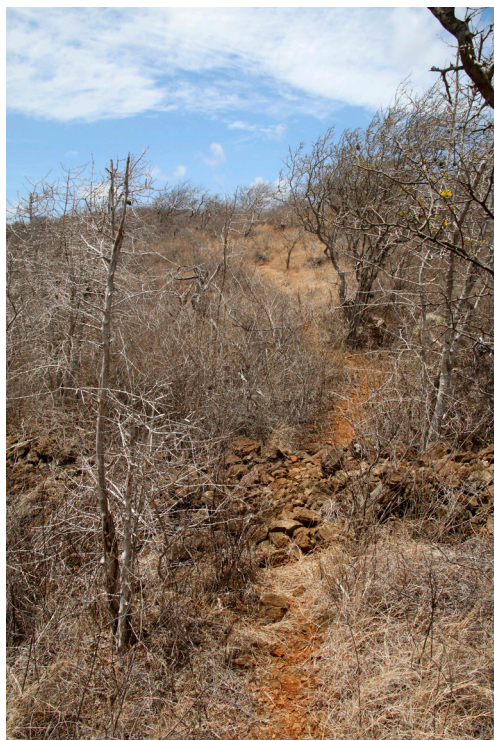
Footpath going up the Seru di Warawara (Warawara hill) at Santa Cruz, Curaçao, at the end of a long period of drought (24 May, 2014). In the picture a low dam running across the hill can be seen. Such structures are called "faha" meaning belt. Many were constructed in the past to conserve run-off rainwater, forcing the water into the ground, and also to a lesser extent to combat erosion.

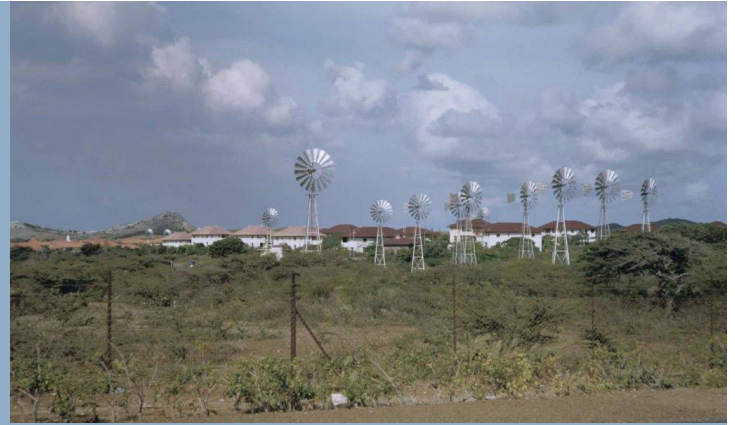
Picture on the right: The dam at Julianadorp. Windmills with extra large capacity and higher towers were used. The wind wheels seem to be either 10 or 12 ft diameter. The picture was probably taken in the 1950's; in the background the roofs of the newer houses, the first of which were built in 1947 are visible.

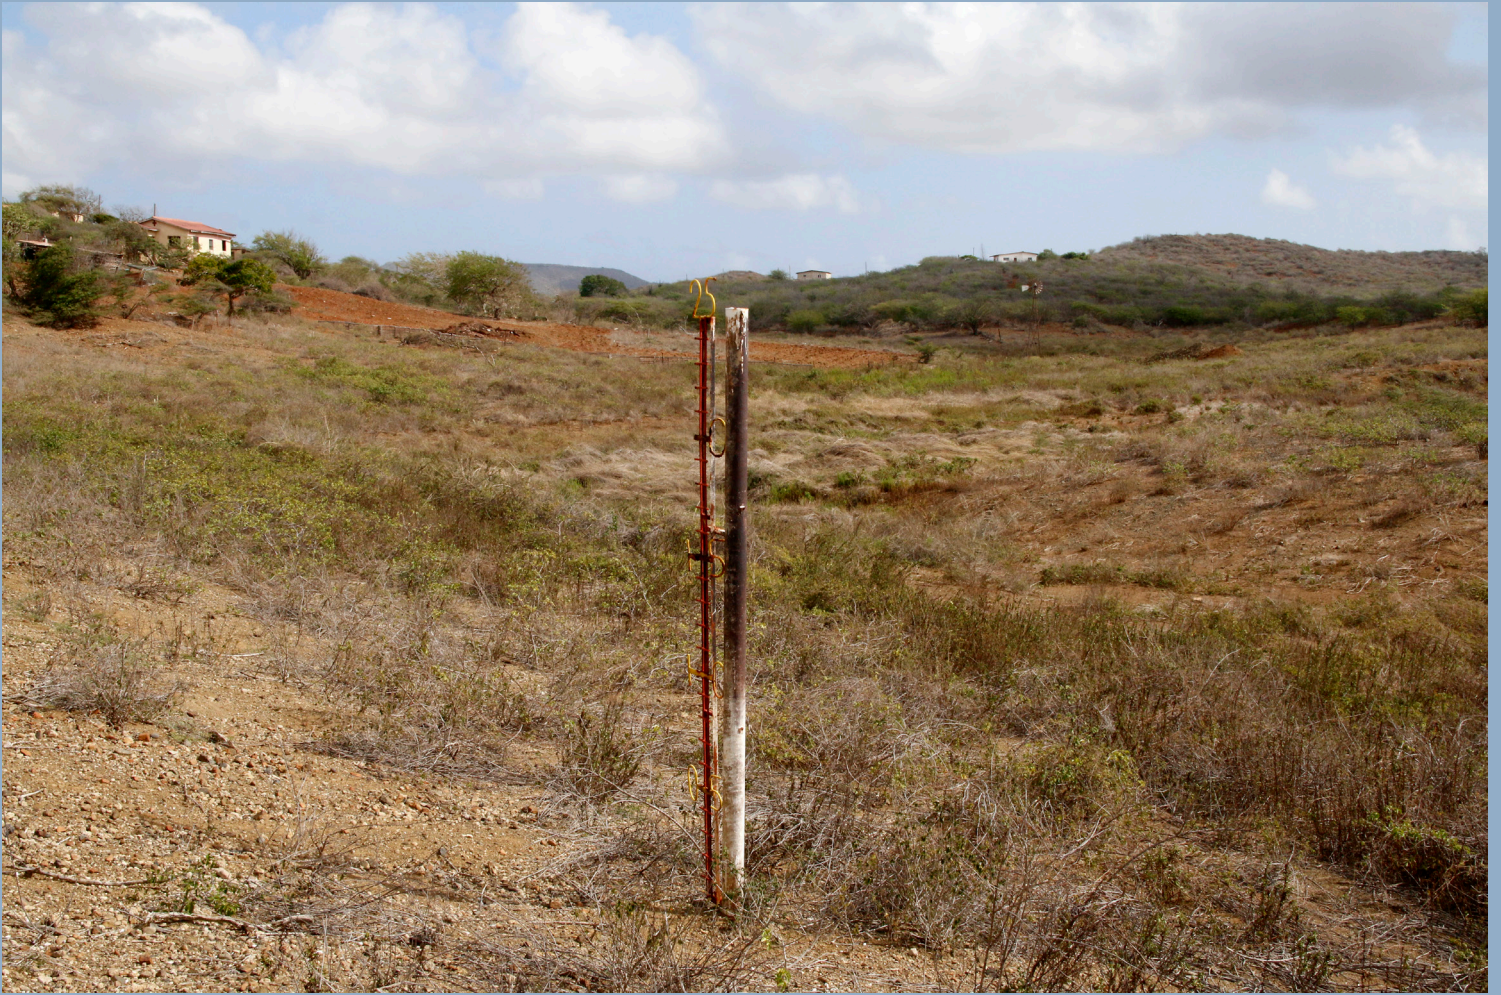
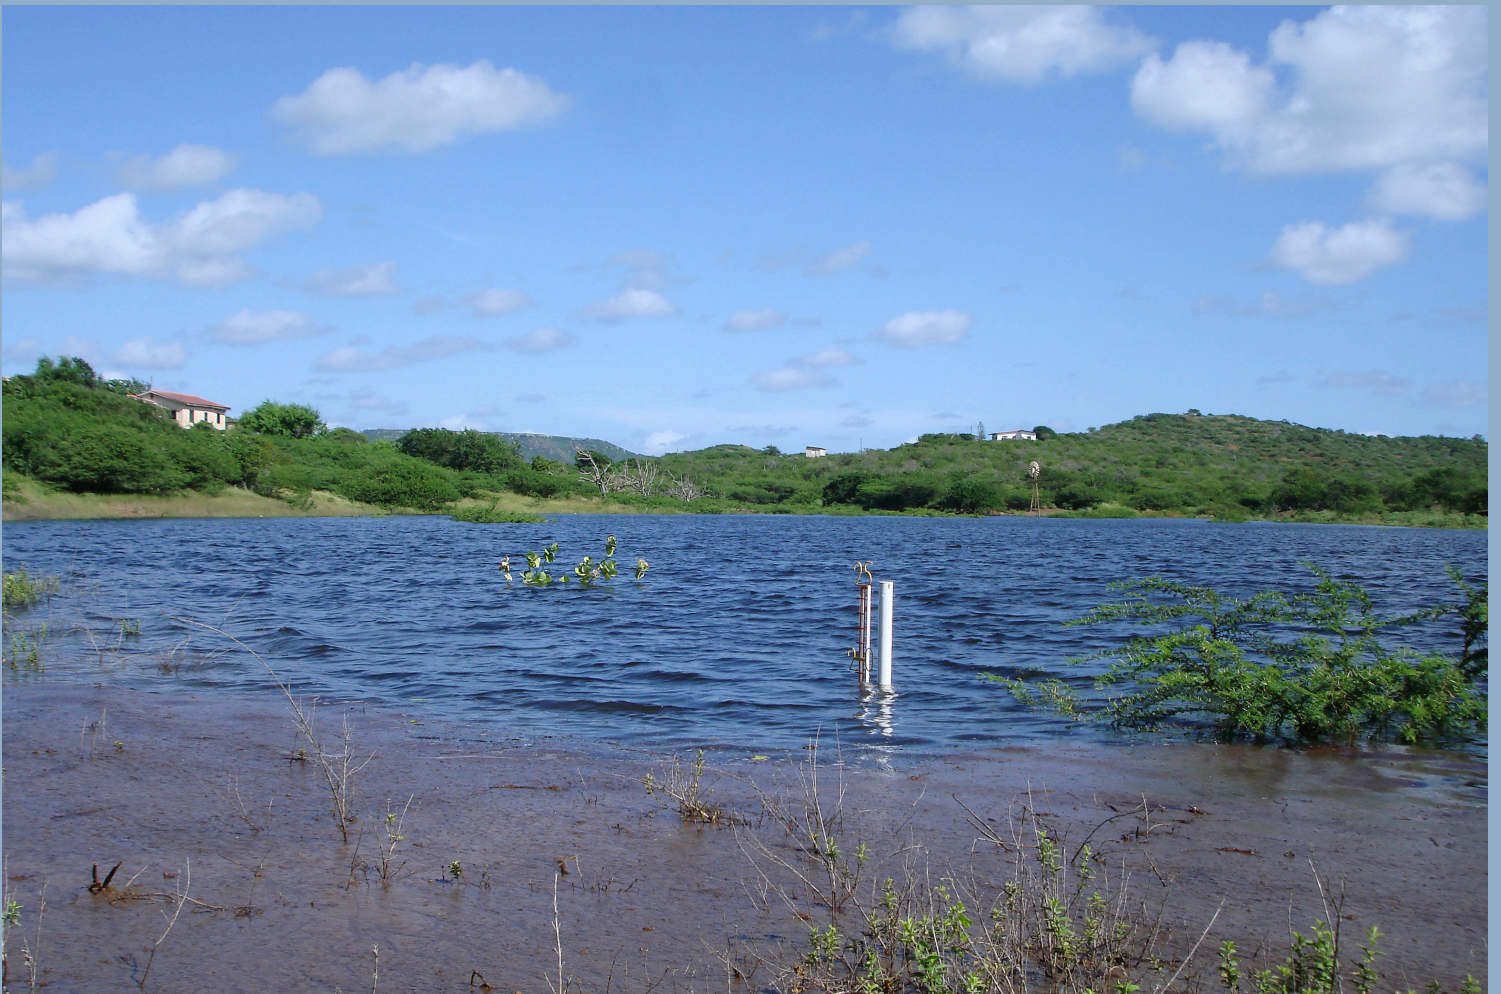
Dam Soto, the second largest one in Curaçao with a capacity of around 450.000 tons. Above on the 18th of September 2016, Below 30th of November 2008. In the picture about 2/3 of the surface area of the dam is visible. Picture Peter C. Winkel

overflow (spillway) is constructed. The overflow is dimensioned to be able to discharge 80 mm of rainfall/ hour falling in the catchment area feeding the dam; assuming the dam is already full. In some cases it is not necessary to construct a masonry overflow. For example where the dam is ending in a hill and the overflow runs over hard rock (for example the Soto dam and a few others as well).

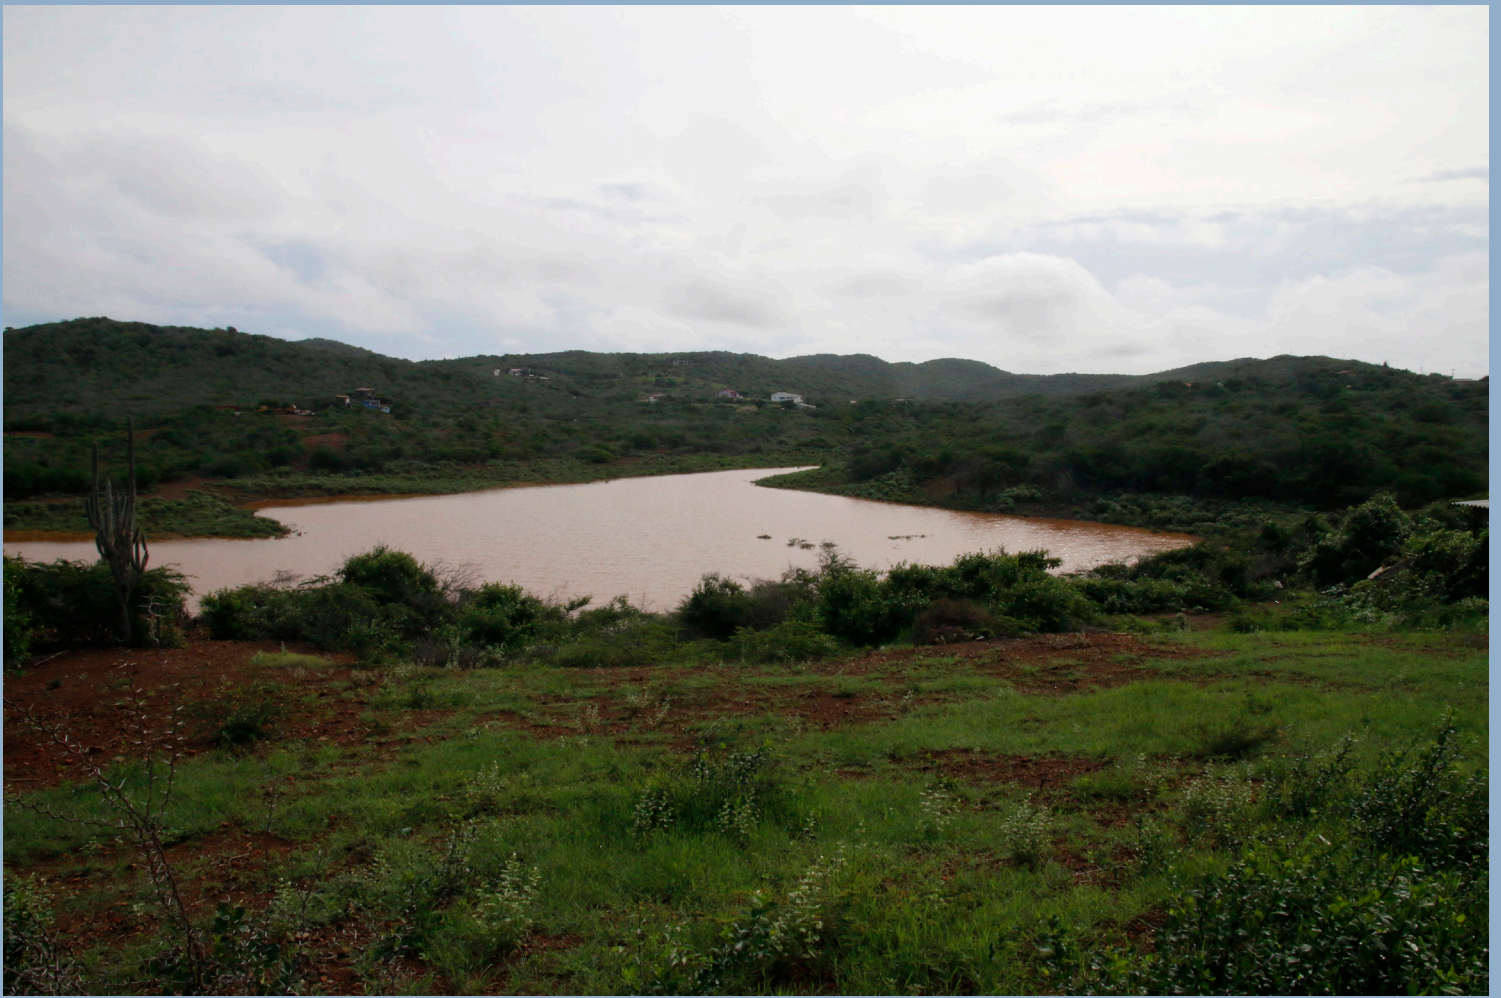
Dam Soto, on the morning of the 27th of November 2016, the dam was almost fully filled by heavy rains the day before; the water is still muddy. After a few days the mud will settle and the lake turns blue. The measuring scale cannot be seen in this picture, it is toward the right (south). The windmill (see on the right) cannot be seen either, it is to the left (north).

*The picture of the windmill was taken on the 30th of November 2008. When the lake is full the water reaches about 1,20 meters below the platform of the windmill; the vanes are 8ft in diameter. The thorn trees in the water are *Acacia tortuosa*, locally called "wabi". These are fast-growing but cannot stand water logging very long. From their presence and size we can deduce that it had been quite a long time ago, at least a few years ago, that water had reached this high a level in the dam and/or that even if it did, the water must have infiltrated quite rapidly for these trees to be able to survive.*

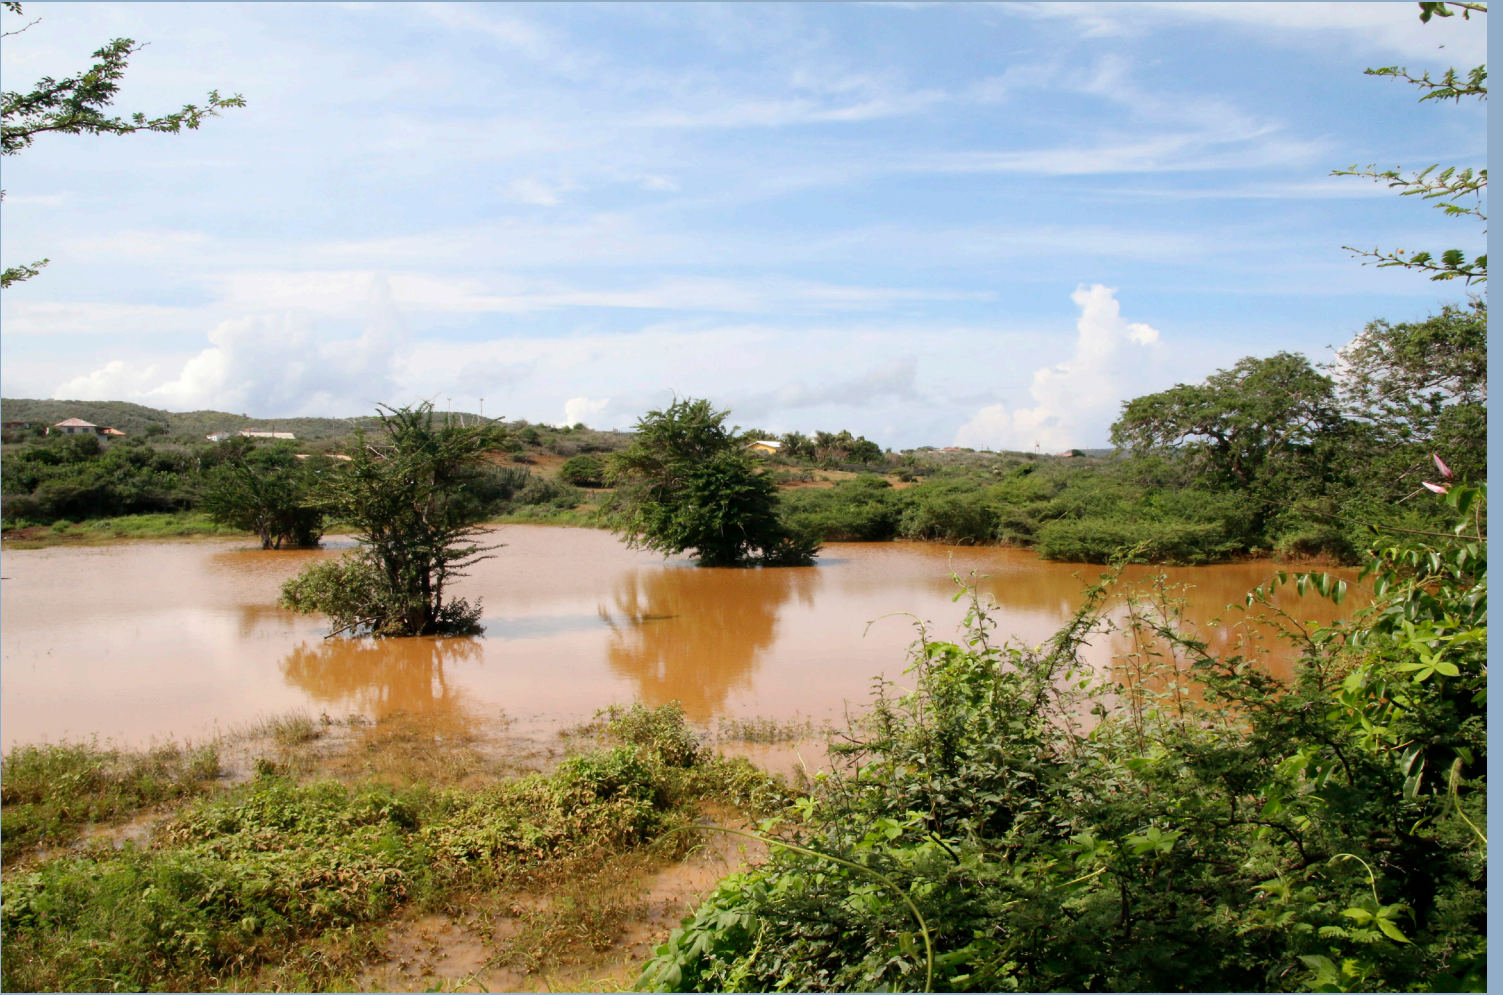
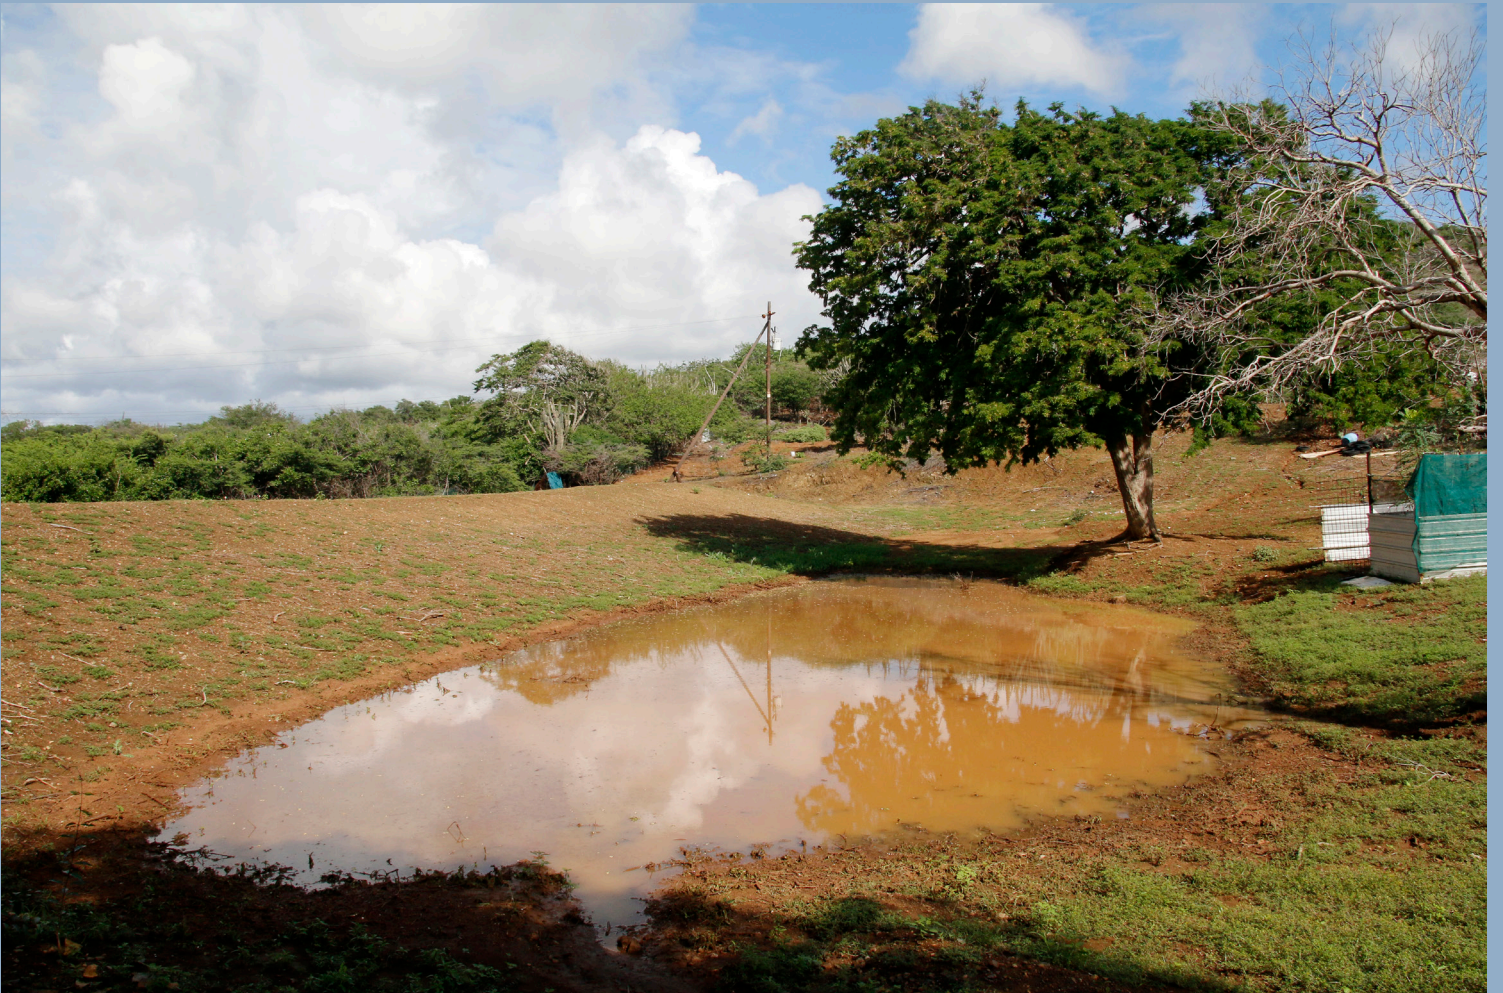
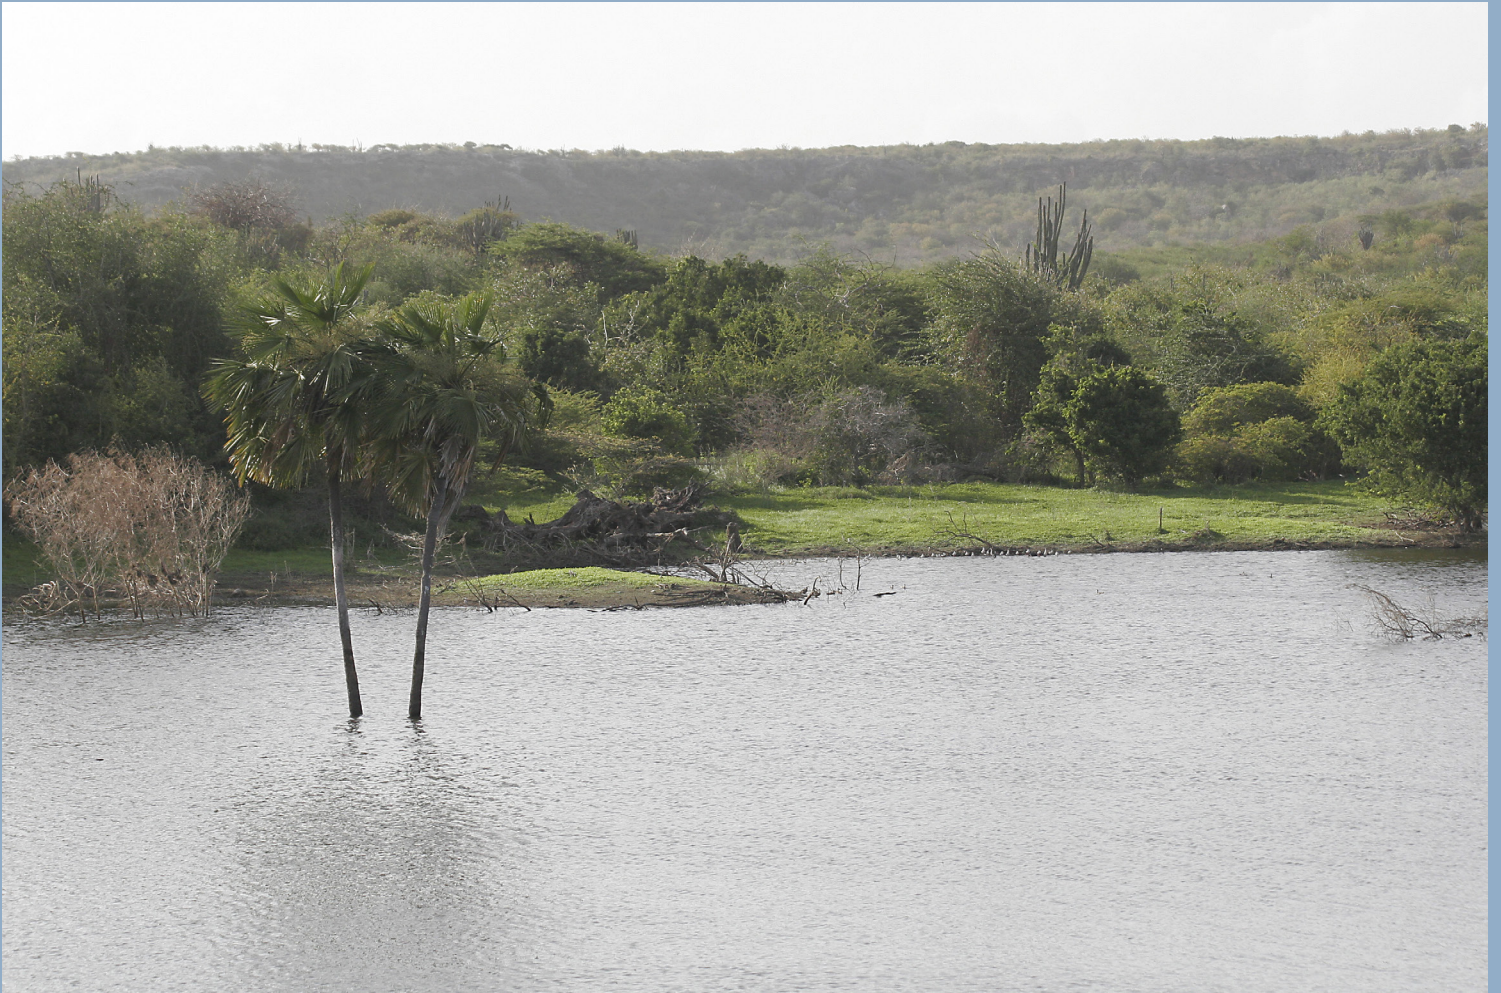
*Dam at Dokterstuijn, Kunuku Kalbas (27 nov, 2016). In this area there is a series of dams, one overflowing into the next. The trees are Calabash trees (*Crescentia cujete*); these can stand water logging and are often found in the basins of dams. Wabi trees (*Acacia tortuosa*) do not survive long periods of immersion.*

*This is an example of a fairly small dam at Pannekoek (22 Nov, 2016). This dam does not have masonry ends; the outflow (the sakadó) is dug into the side of the hill (in front of the electricity pole), where somewhat harder pillow lavas are found. The dam at Soto has a similar outflow. After heavy rains in the past, in 1970, the owner decided to deepen the outflow channel, thus lowering the capacity of the dam. He was afraid the dam would burst. During these rains a dam downstream of this one failed. The tree is a *Lignum vitae* locally called Wayaká (*Guaiacum officinale*), which does not stand water logging very well.*

The dam at Malpaís, locally called Lago disparsé, “the lake that has disappeared”. Even though in this picture the lake has reappeared it is still called Lago disparsé (26 Nov, 2016). A fairly large dam & reservoir constructed by Shell to obtain water for the refinery. Nowadays water is not extracted anymore and it is a nature area with many water birds

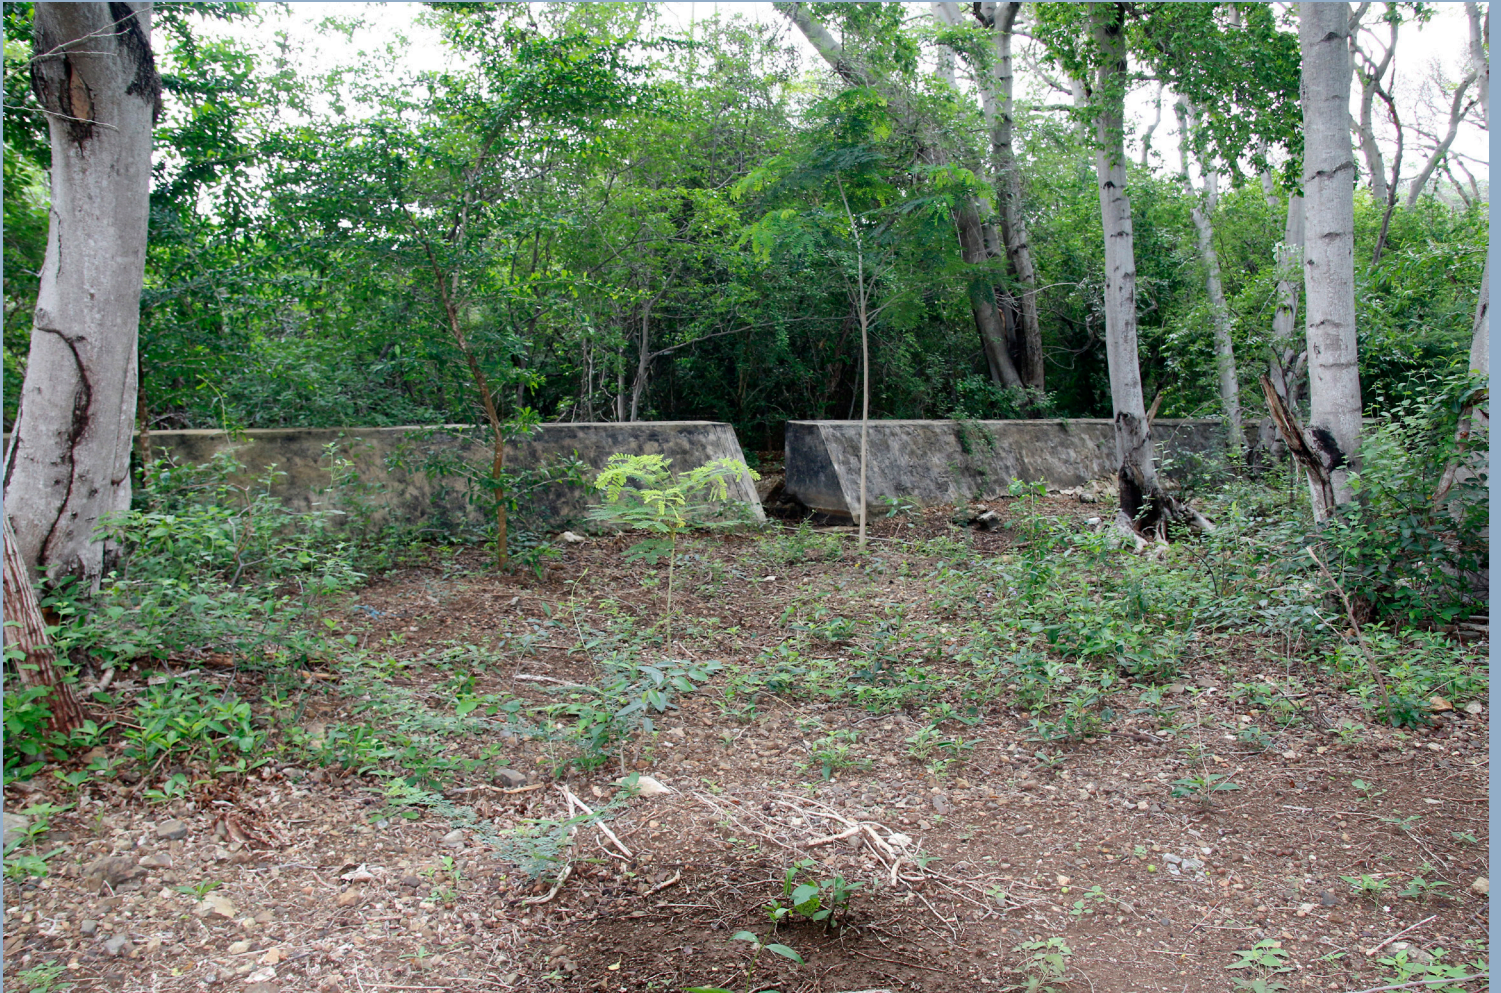
This is a masonry dam, downstream from the dam Kacho, at Klein Sta. Martha. It is the last one before the water reaches the sea (Sta. Martha inner bay). It is a fairly long dam, which overflows fully, over its whole length during a good rainy season. This dam has an unusual feature, a door that could be opened or closed. According to a knowledgeable informant from this area, Mr. Alberto Wendell, this door was used in the past to let the first water after heavy rains escape to the sea. This water would be most heavily laden with salts. This dam is already marked on the old "Werbata" map of 1911-1915. A few more examples of sluice doors like this exist in Curaçao; but they are not very common.
